The German Base « the Bank » at Mûrs-Érigné (Anjou - FR)

By G. Tomezzoli¹

Abstract

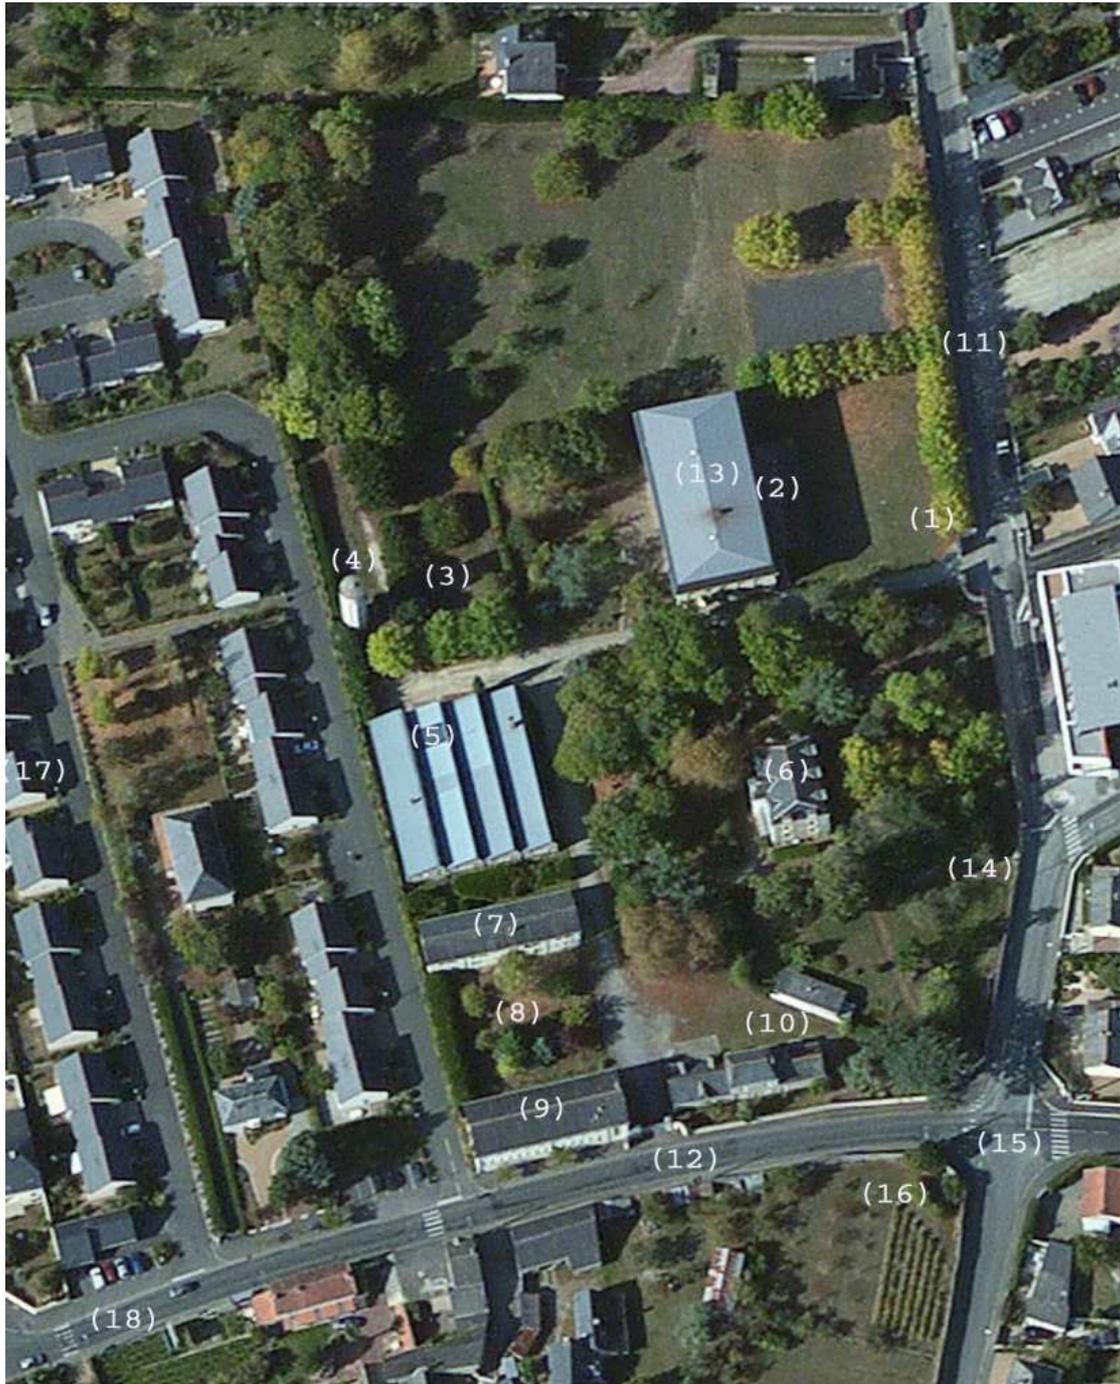
Figure 1. The Bank and the Domaine de La Dubinière (47° 24' 4,3" ; 0° 31' 36.6" W):
 (1) main entrance; (2) C.I.C. building; (3) pool - nowadays filled by ground; (4) water tower; (5) garages; (6) castle of La Dubinière - lodgments of German officers; (7) - (9) barracks – lodgements of soldiers, infirmary and different services; (8) place of a demolished barrack; (10) dependences of the castle; (11) Saint Vincent road; (12) Louis Rabineau road; (13) placement of a 20 mm antiaircraft double gun; (14) machine gun casemate; (15) machine gun casemate; (16) machine gun casemate; (17) machine gun casemate; (18) antitank obstacle - [Flash Earth]

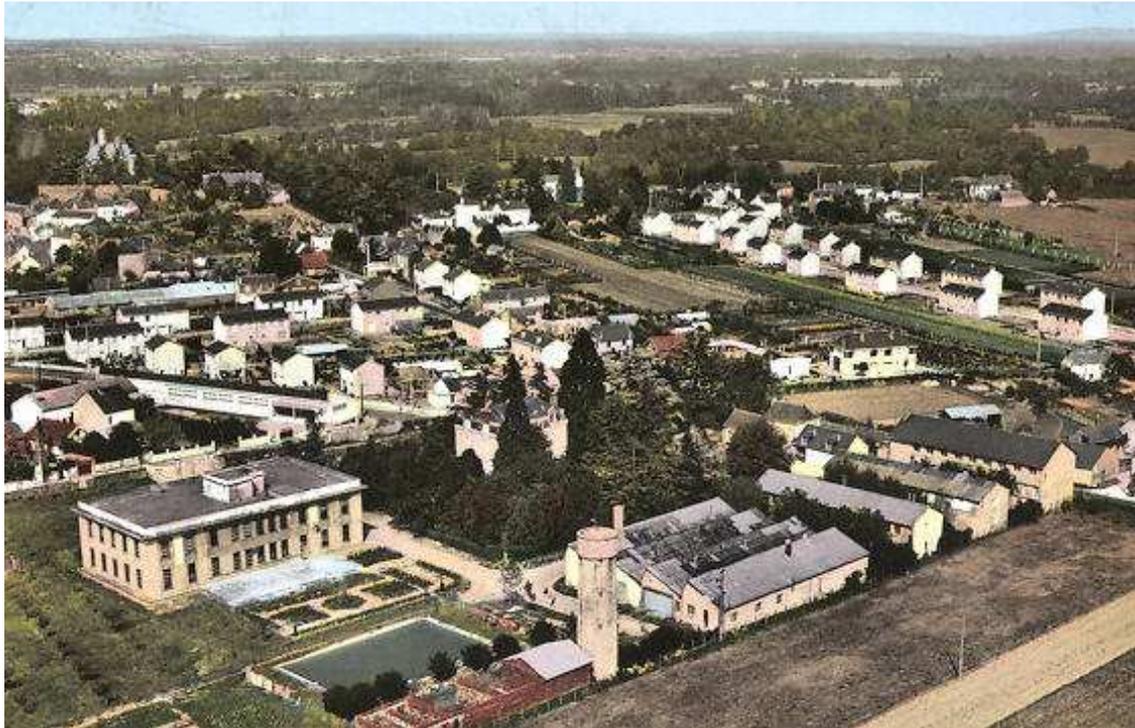
Figure 2. The Bank - after war image; on the left: C.I.C. building with place of the antiaircraft gun on the roof, pool and water tower; in the middle: castle of La Dubinière partially masked by trees; on the right: garages and the three barracks for hosting soldiers and different services – visible, between the first and the last barrack, is the demolished barrack

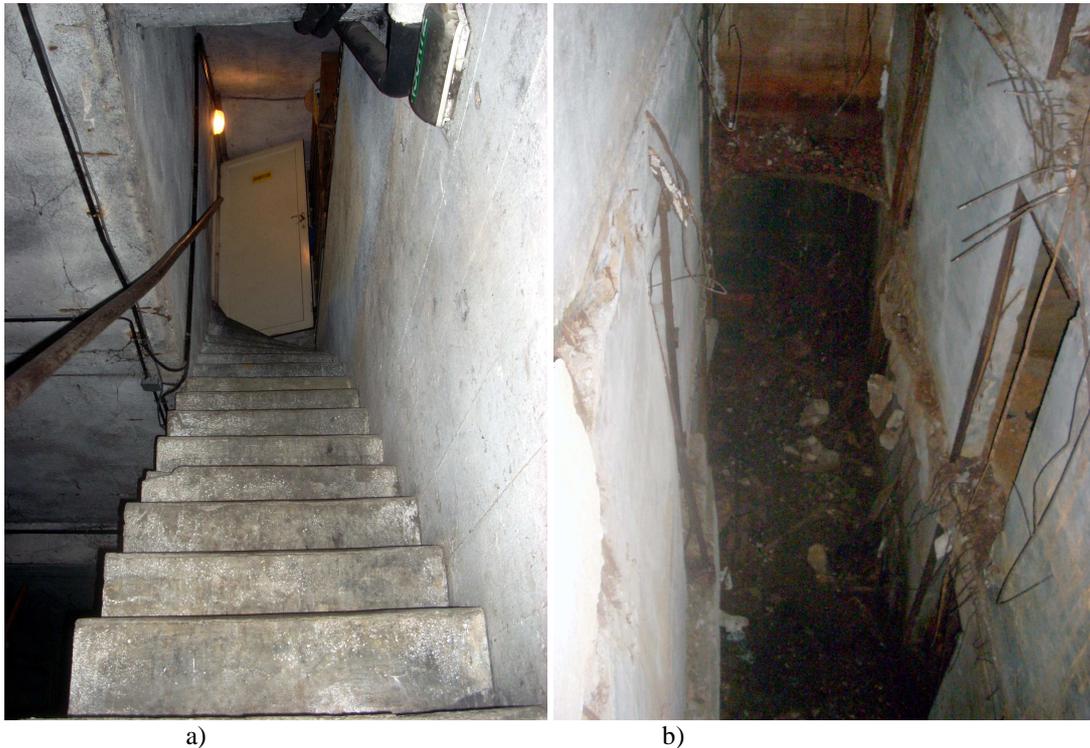
My visit of the site of the Bank (**Figures 1-2**), was organized thanks to father Gérard Fouquet of the Congregation, and took place on 23 August 2011. It permitted the visit of the aboveground and the underground floors of the C.I.C building. The aboveground floors preserve the security doors and the original safe rooms used now for library and the activities of the Congregation. A passage in the 1.25 m thick concrete layer allows descending in the first underground floor (**Figure 3**). The original heating system and its fuel tanks disappeared substituted by a modern gas heating system (**Figure 4**). A large opening in the first underground floor, caused by the explosions, allows having a vision of the other two underground floors devastated by the explosions.

Figure 3. C.I.C. building: a) descent stair through the 1.25 m thick concrete layer to the first underground floor; b) opening in the first underground floor and vision of the second and third devastated underground floors

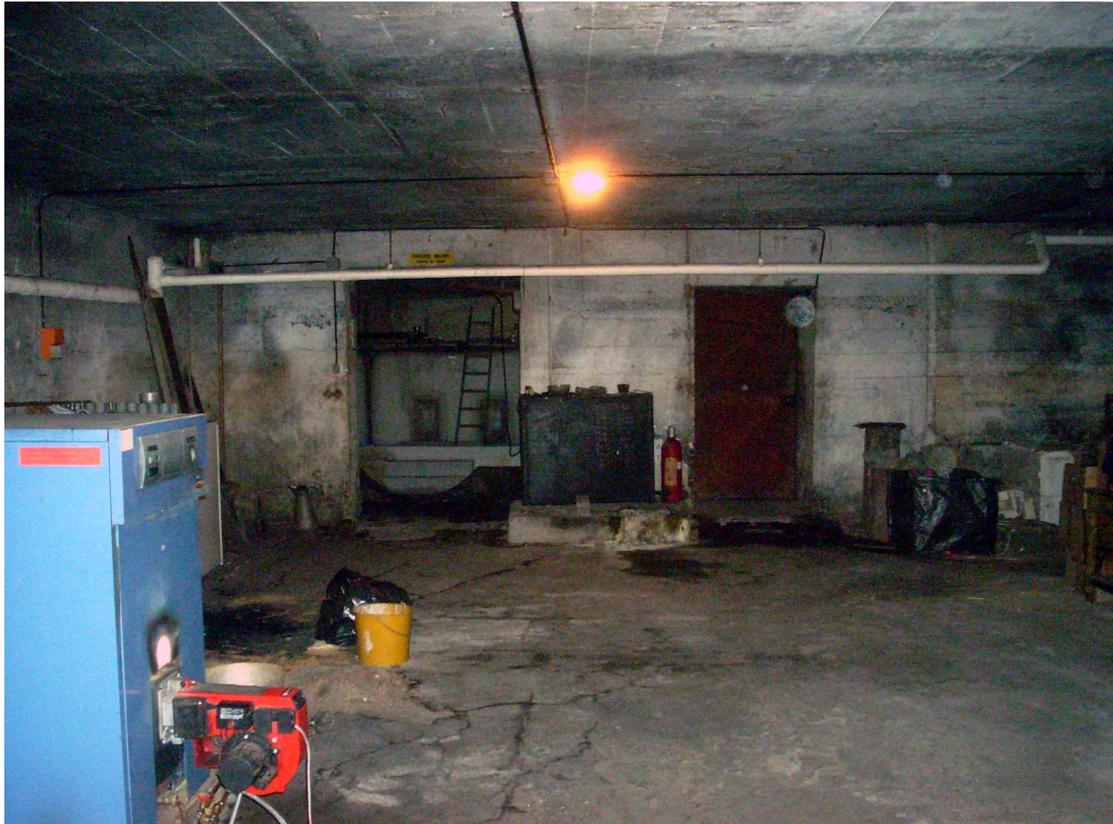
Figure 4. C.I.C. building: first underground floor - rooms of the heating system and fuel tanks on the left side the modern gas heating system

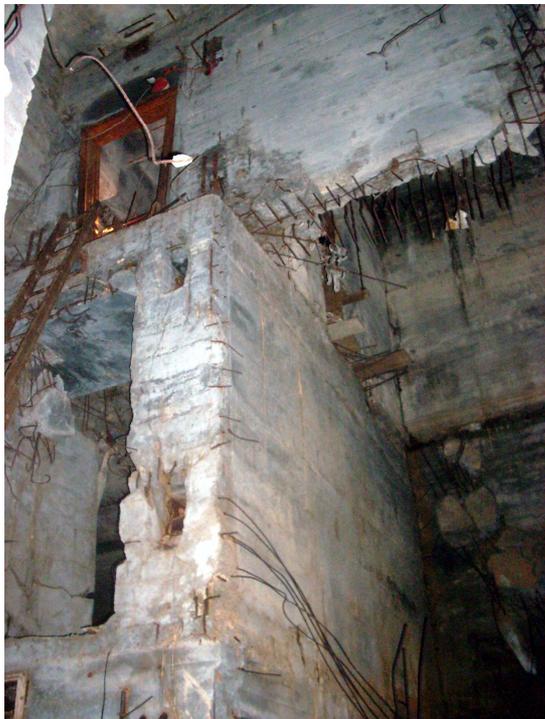
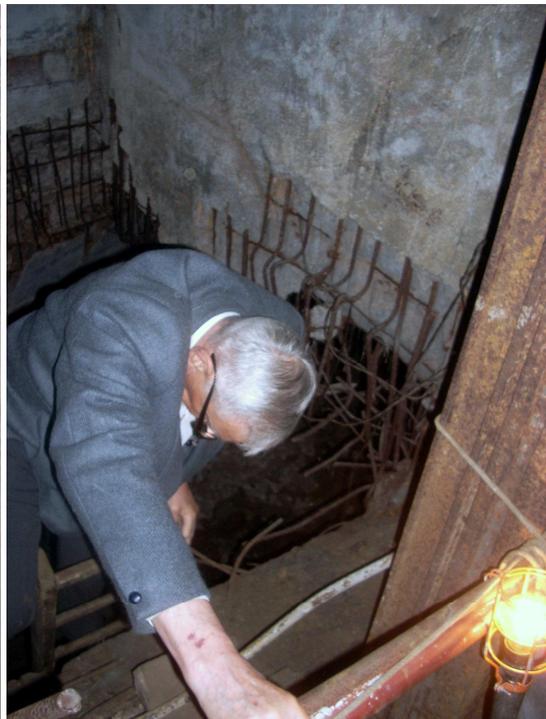
A wood stair, robust, but fragile in the appearance, (**Figure 5**) allows the descent to the second floor and, walking on the debris, it is possible to reach the third underground floor (**Figures 6-17**).

Figure 5. C.I.C. building: a) second and third devastated underground floors, on the left wood stairs; b) first underground floor, father Fouquet during the descent to the third underground floor

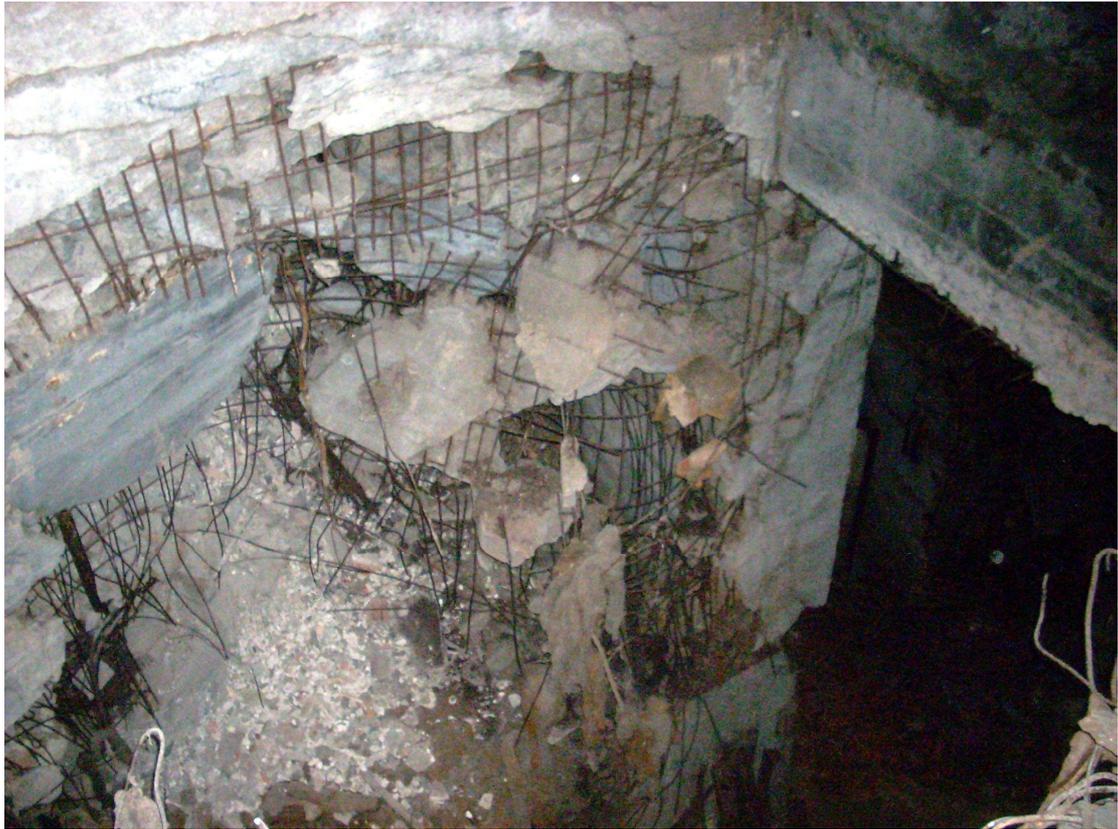
Figure 6. C.I.C. building: devastated second underground floor and vision to the third underground floor

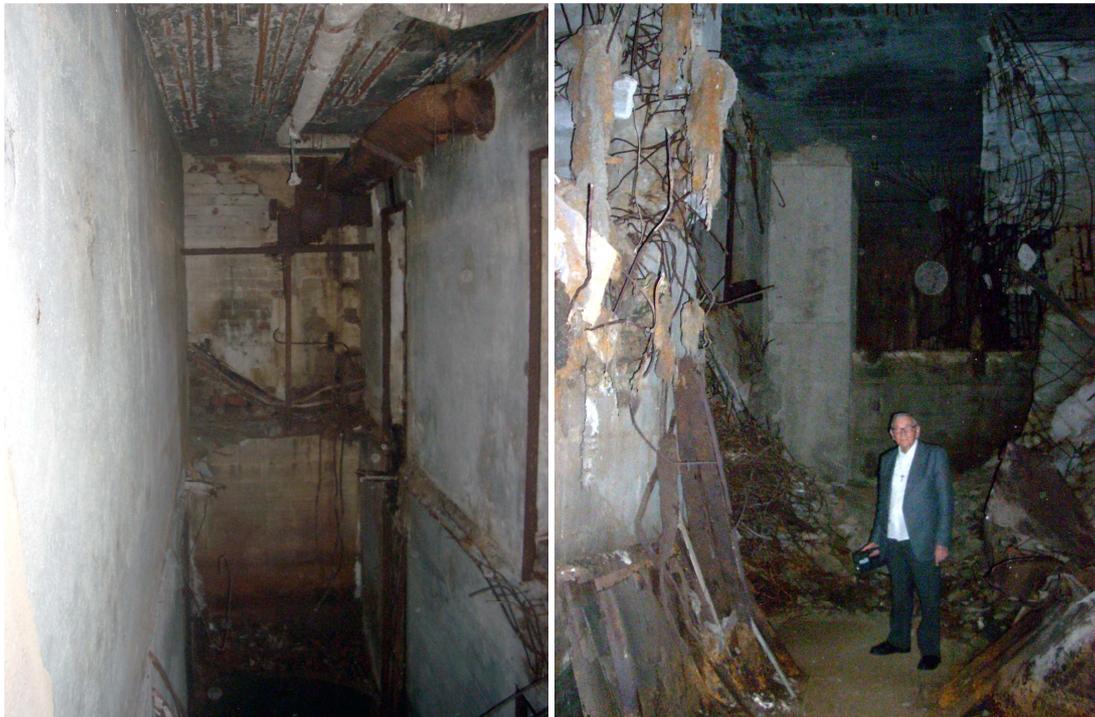
Figure 7. C.I.C. building: a) devastated second and third underground floors; b) father Fouquet in the deep of the third underground floor

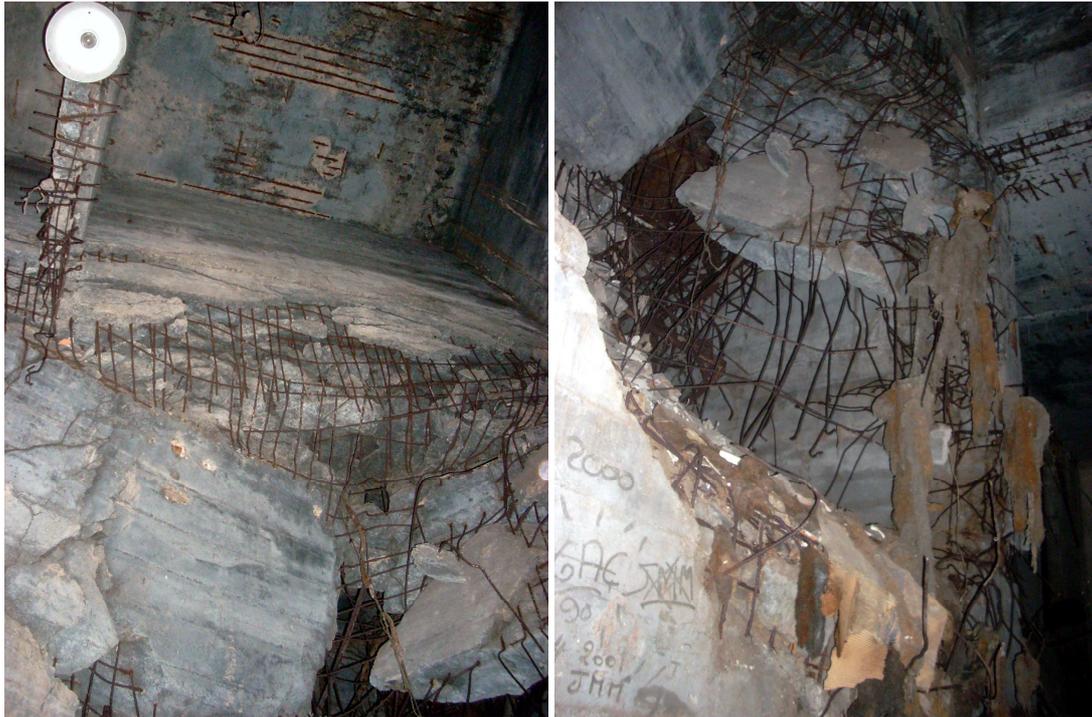
Figure 8. C.I.C. building: a), b) damages in the second underground floor seen from the third underground floor

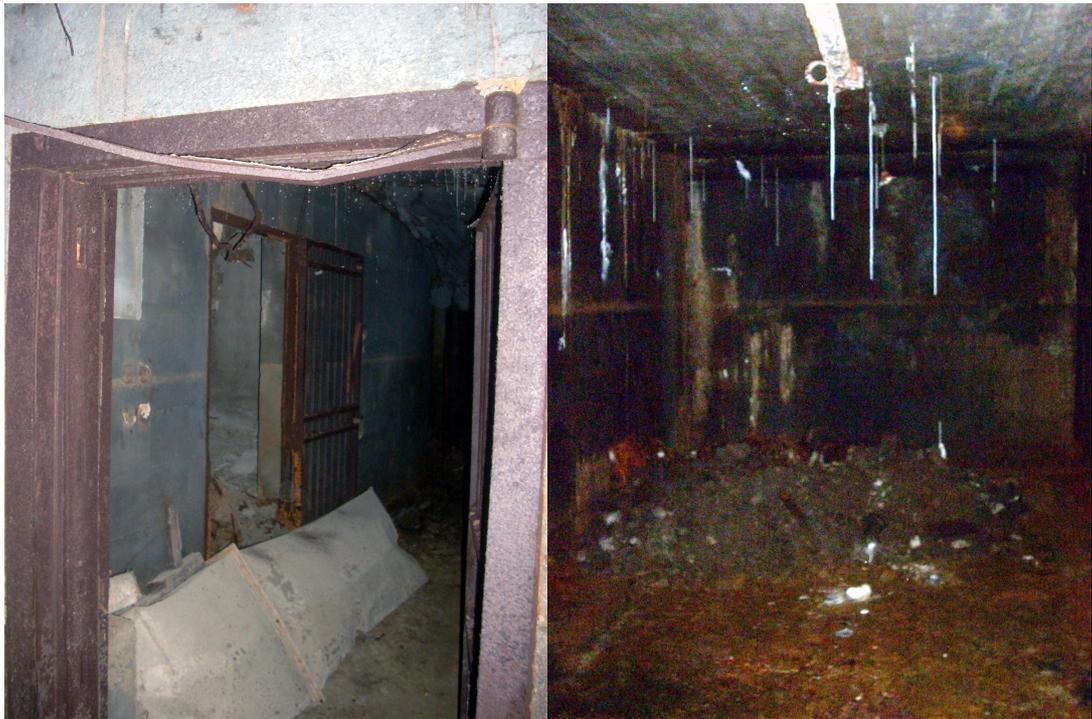
Figure 9. C.I.C. building: a), b) safe rooms in the third underground floor

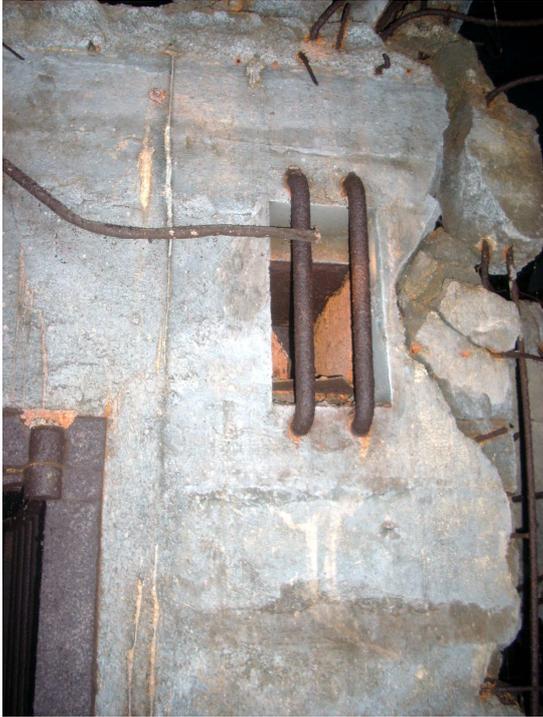
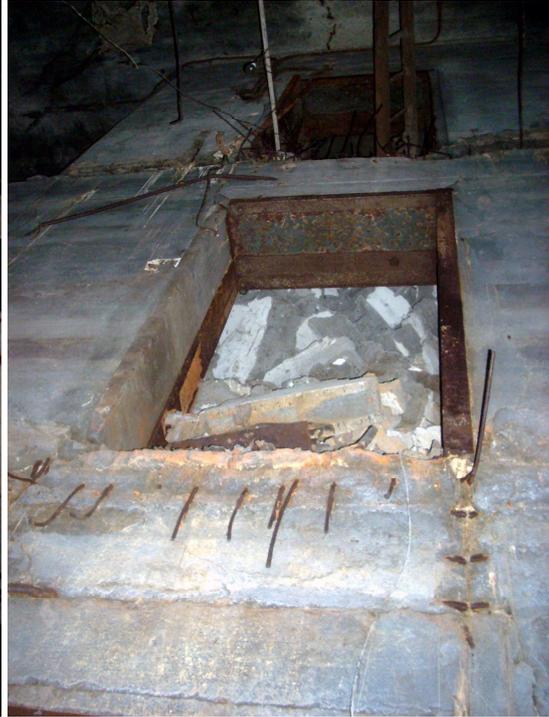
Figure 10. C.I.C. building: a) damages in the third underground floor; b) damages to the second and first underground floors seen from the third underground floor

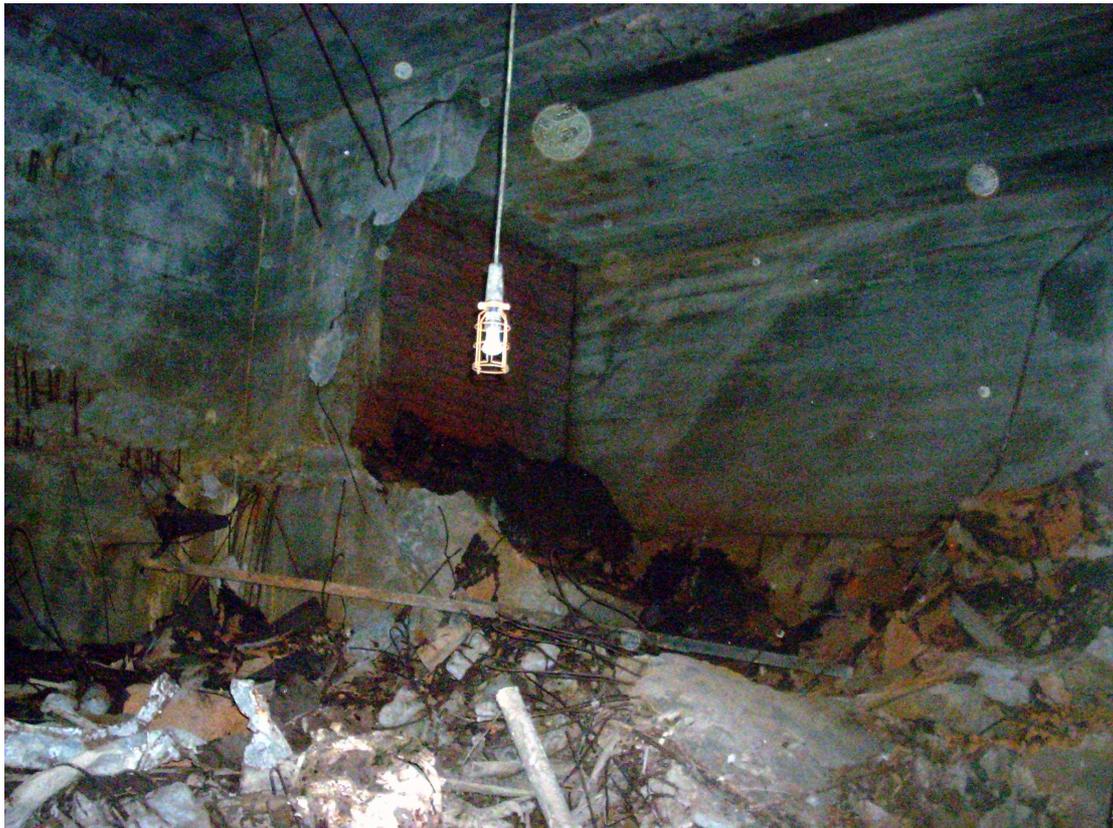
Figure 11. C.I.C. building: damages in the third underground floor

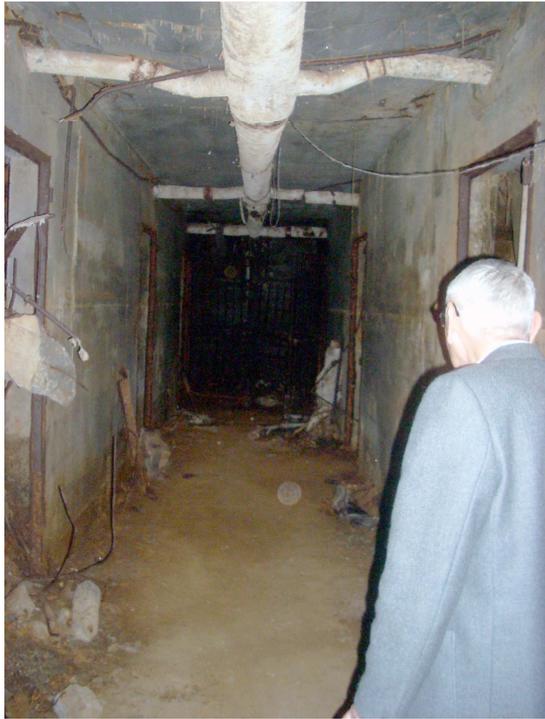
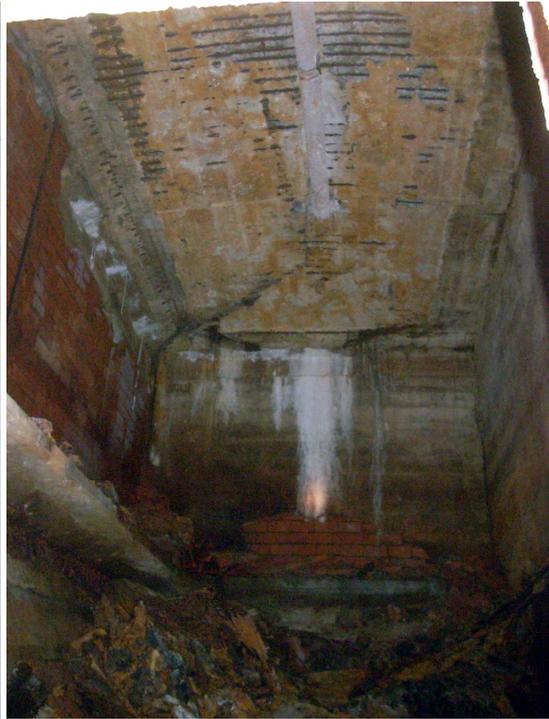
Figure 12. C.I.C. building: a) corridor in the third underground floor; b) vision of the ceiling of the second underground floor curved by the pressure developed by the explosion

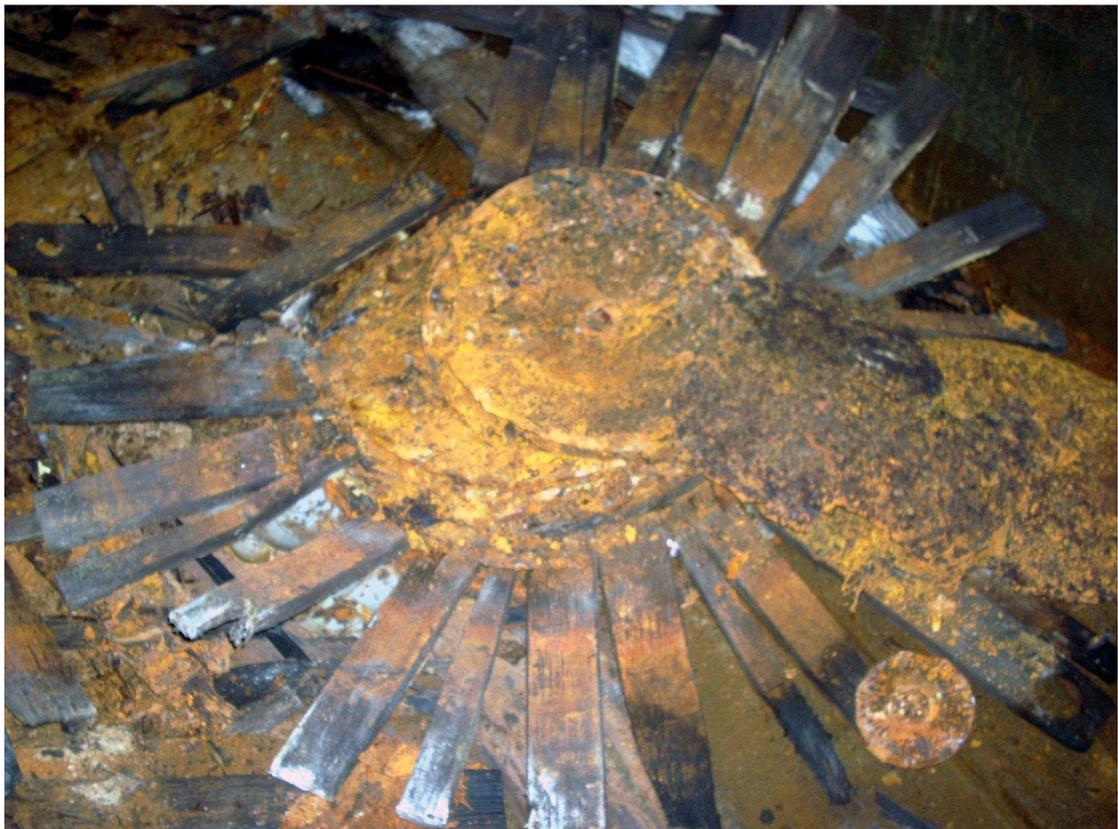
Figure 15. Rests of a pulley for rolling cables of the lift

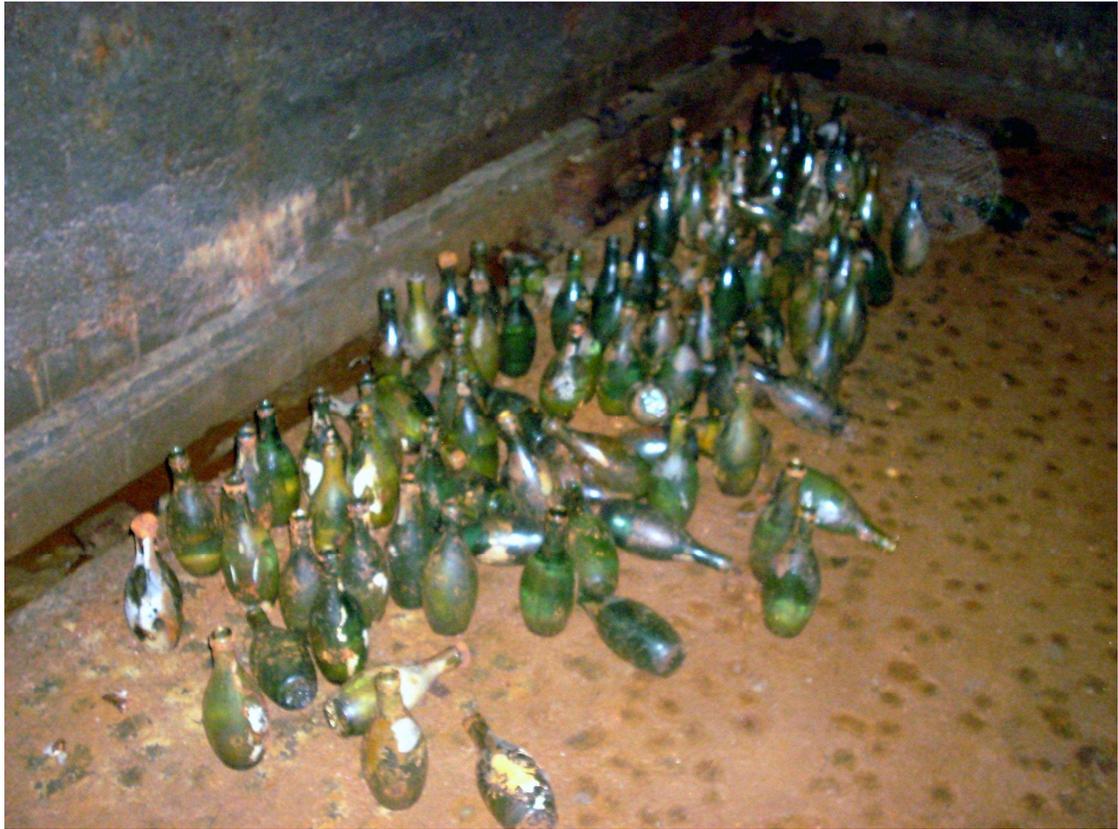
Many questions concerning the C.I.C building have received reply by a Mr. Suquet's personal communication (Suquet, 2011). Mr. Suquet attests that the lots of metal scrap in the third underground floor were produced by the explosion which caused a violent fire lasting three days; the explosion also destroyed the water pumps which caused the water to invade the three underground floors up to the 1.25 meters layer for a period of ten years. Important stocks of ammunitions not reached by the explosions and in perfect state of preservation and therefore in a very dangerous state were evacuated by the French Civil Protection Service. The beds date actually of the period of the war and were probably used by the German soldiers. The kitchen furniture are probably of German construction (**Figures 13-14**). The German soldiers have well appreciated the mineral water Perrier according to the great number of bottles dating of the period of the war that survived the explosions, the fire and the inundation of the underground floors (**Figure 16**).

Figure 16. Bottles of mineral water Perrier survived to the explosions and the fire in the third underground floor

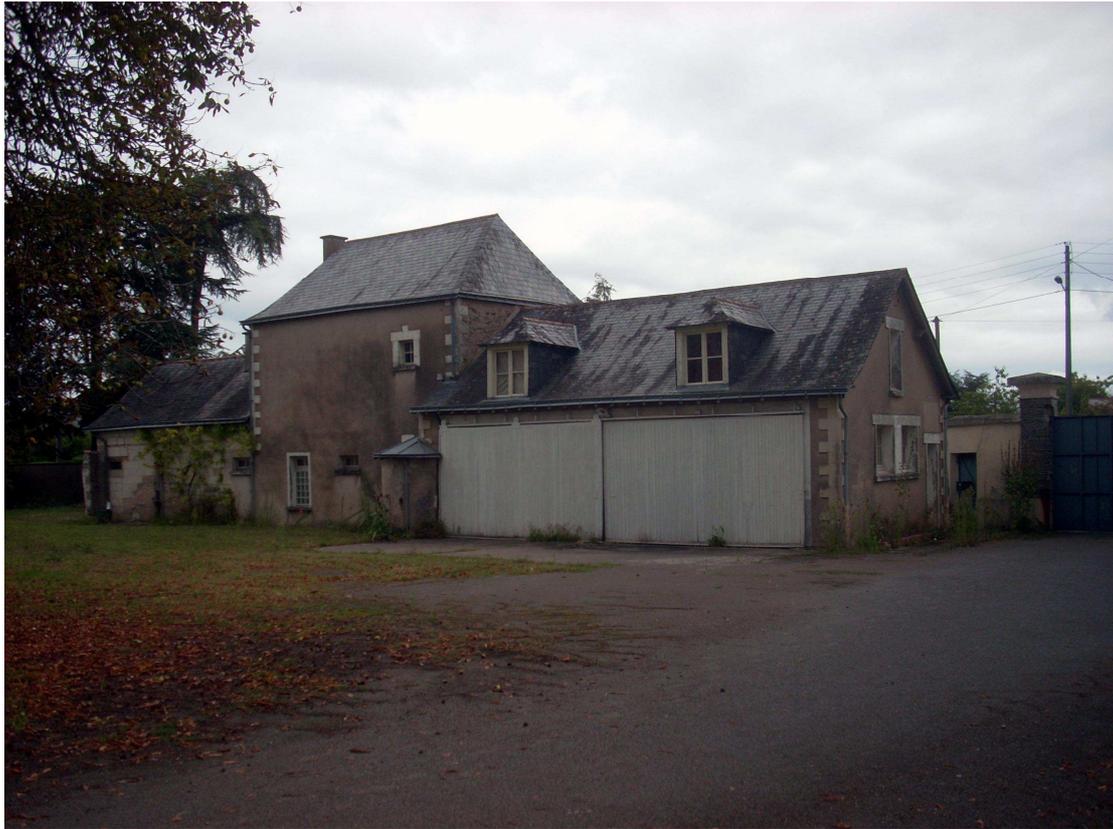
Figure 22. Castle dependences - the great doors on the facade suggest a possible vehicle garage or repair store utilization of a portion of the dependences
