# The German Base “the Bank” at Mûrs-Érigné (Anjou-FR)

**Giancarlo T. Tomezzoli**

## 3. Vestiges of “the Bank”

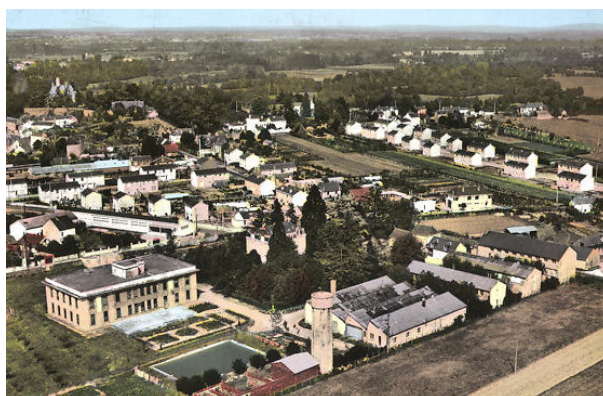
**Figure 1.** The Bank—after war image; on the left: C.I.C. building with emplacement of the anti-aircraft gun on the roof still visible, pool and water tower; in the middle: castle of La Dubinière partially masked by trees; on the right: garages and the three barracks for hosting soldiers and different services—visible, between the first and the last barrack, is the demolished barrack.

The preservation state of the C.I.C. building is rather good. The two aboveground floors are currently in use for the activities of the Congregation, although the renovation of the roof caused the disappearing of the emplacement of the anti-aircraft gun. The garages, the barracks and the dependences of the castle (**Figures 18-21**) due to their rather large dimensions are still, although partially, in use. The water tower (**Figure 20**) is still used by the municipality of Erigné. The castle of La Dubinière (**Figure 22**) is a private property and not accessible to the public, however, many bullet holes on the facade witness past combats.

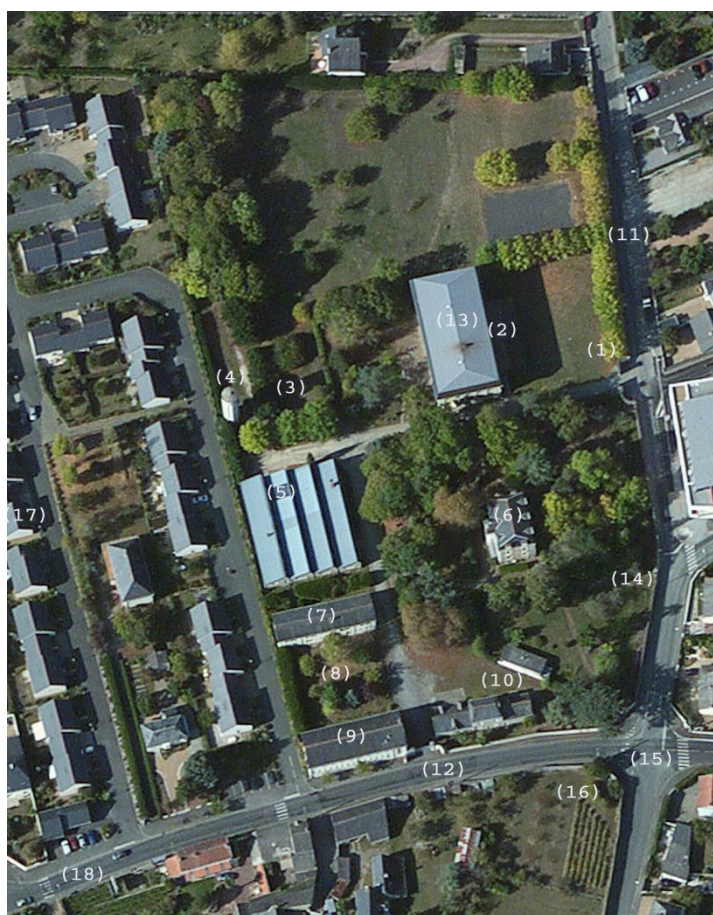
**Figure 2.** The Bank and the Domaine de La Dubinière (47°24'4.3"; 0°31'36.6"W): (1) main entrance; (2) C.I.C. building; (3) pool—nowadays filled by ground; (4) water tower; (5) garages; (6) castle of La Dubinière—lodgment of German officers; (7)-(9) barracks—lodgment of soldiers, infirmary and different services; (8) place of a demolished barrack; (10) dependences of the castle; (11) Saint Vincent road; (12) Louis Rabineau road; (13) emplacement of a 20 mm anti-aircraft gun; (14) machine gun casemate disappeared; (15) machine gun casemate disappeared; (16) machine gun casemate disappeared; (17) machine gun casemate disappeared; (18) antitank obstacle disappeared—[Flash Earth].

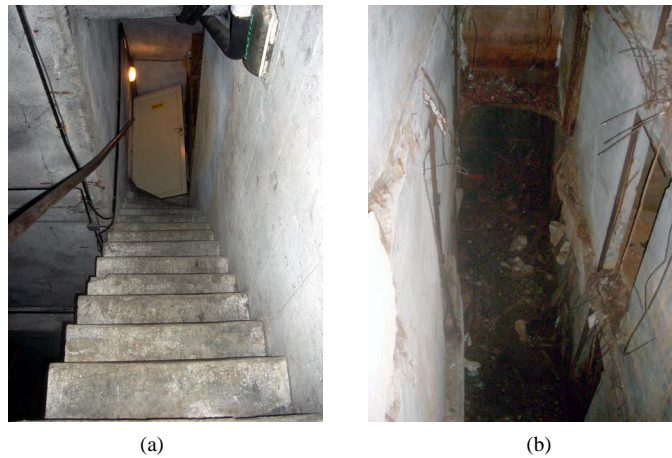
**Figure 3.** C.I.C. building: (a) descent stair through the 1.25 m thick concrete layer to the first underground floor; (b) opening in the first underground floor and vision of the second and third devastated underground floors.

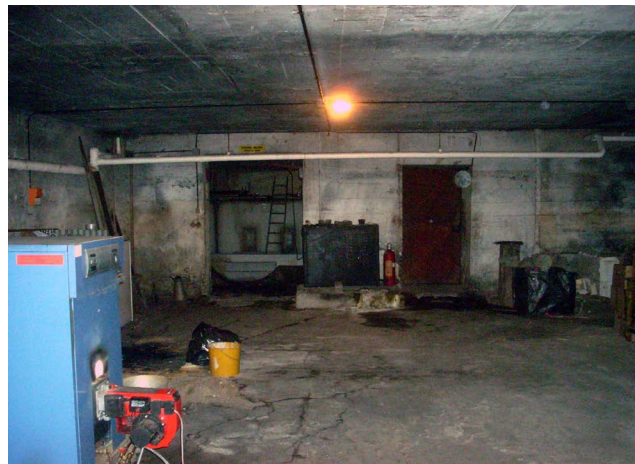
**Figure 4.** C.I.C. building: first underground floor—rooms of the heating system and fuel tanks disappeared, on the left side the modern gas heating system.

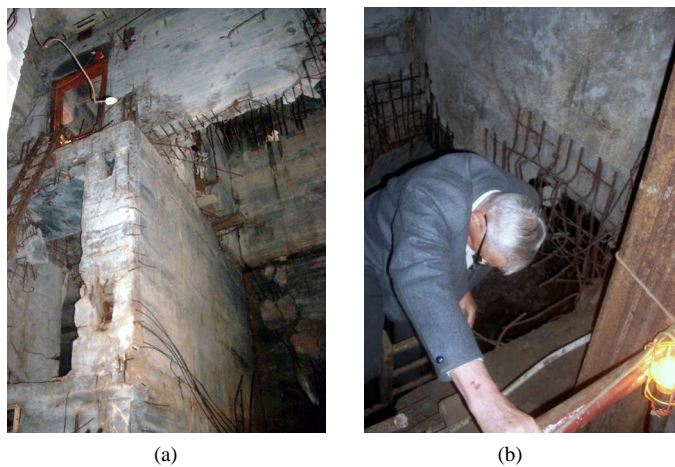
**Figure 5.** C.I.C. building: (a) second and third devastated underground floors, on the left wood stair; (b) first underground floor, father Fouquet during the descent to the third underground floor.

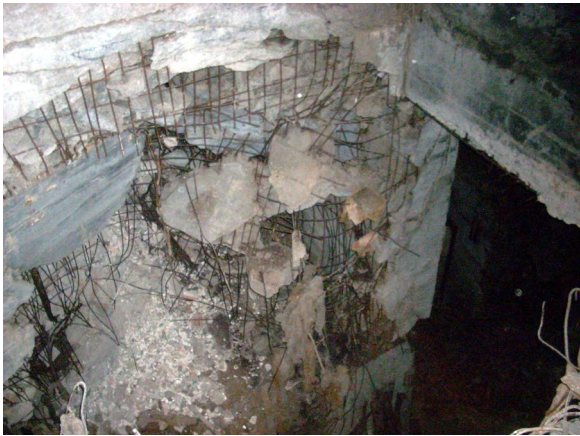
**Figure 6.** C.I.C. building: devastated second underground floor and vision to the third underground floor.

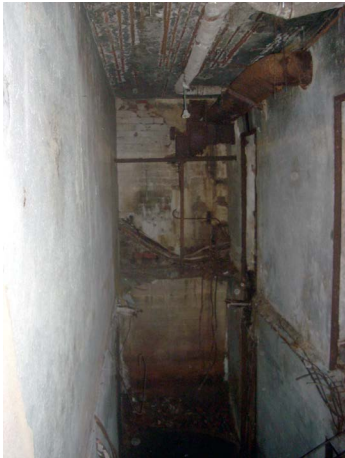
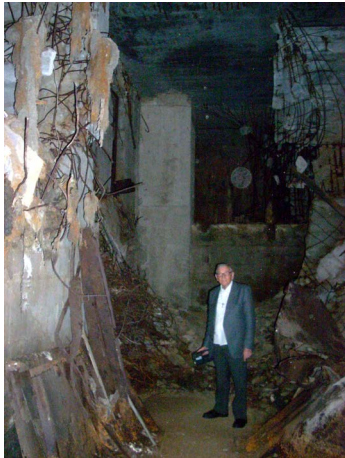
**Figure 7.** C.I.C. building: (a) devastated second and third underground floors; (b) father Fouquet in the deep of the third underground floor.

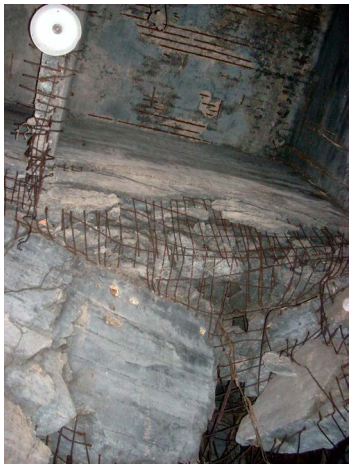
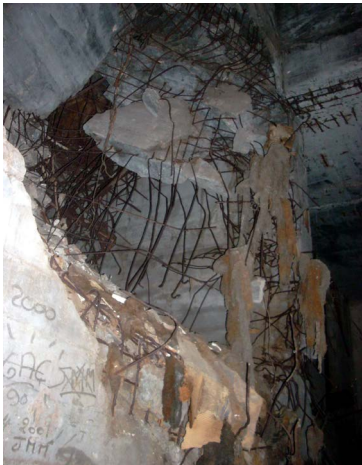
**Figure 8.** C.I.C. building: (a), (b) damages in the second underground floor seen from the third underground floor.

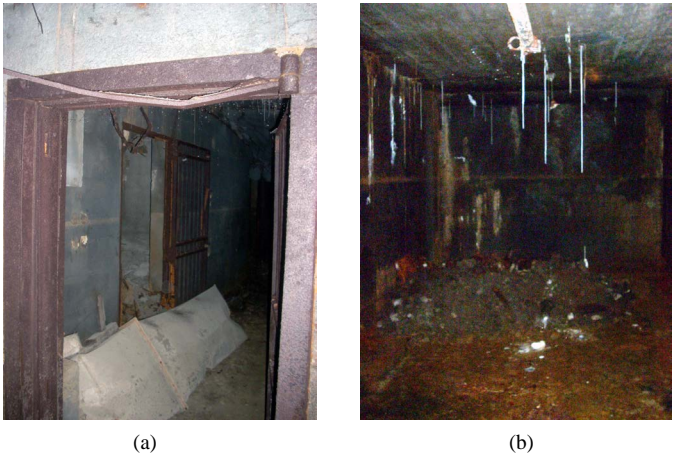
**Figure 9.** C.I.C. building: (a), (b) safe rooms in the third underground floor.

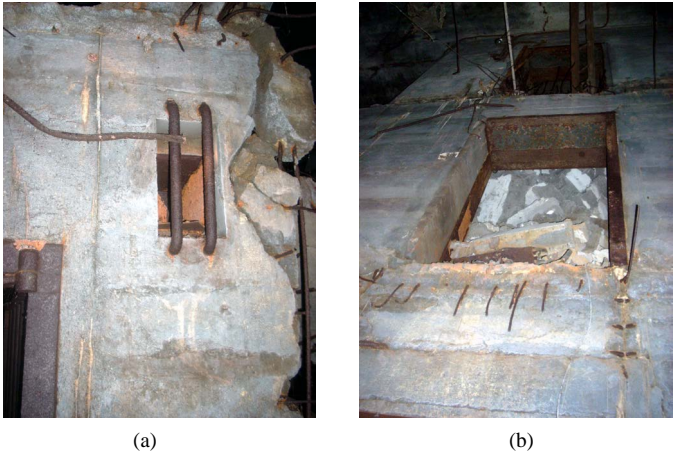
**Figure 10.** C.I.C. building: (a) damages in the third underground floor; (b) damages to the second and first underground floors seen from the third underground floor.

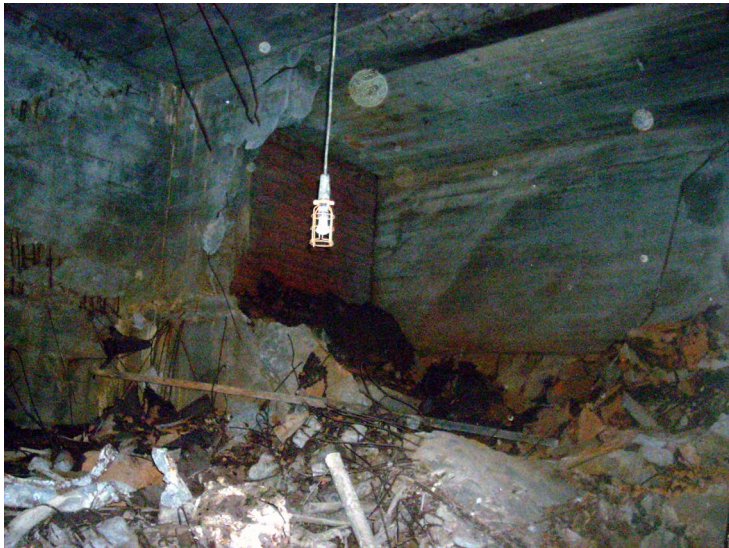
**Figure 11.** C.I.C. building: damages in the third underground floor.

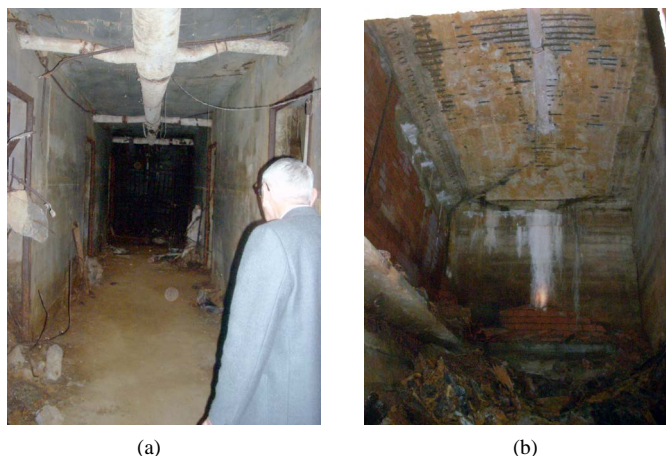
At the moment of evacuating the Bank in August 1944, the Germans dynamited the C.I.C. building in the attempt of destroying it. The explosions damaged the lift conduit on the length of six meters and created an empty space of about ten meters of length and six meter of bright in the underground floors, but the 1.25 meter thick concrete layer contained the explosions and avoided the destruction of the two aboveground floors (Suquet, 2009).

**Figure 12.** C.I.C. building: (a) corridor in the third underground floor; (b) vision of the ceiling of the second underground floor curved by the pressure developed by the explosions.

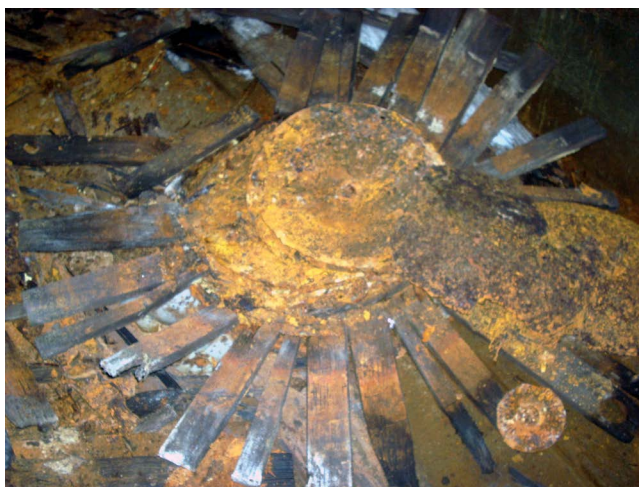
**Figure 15.** C.I.C. building: rests of a pulley for rolling cables of the lift.

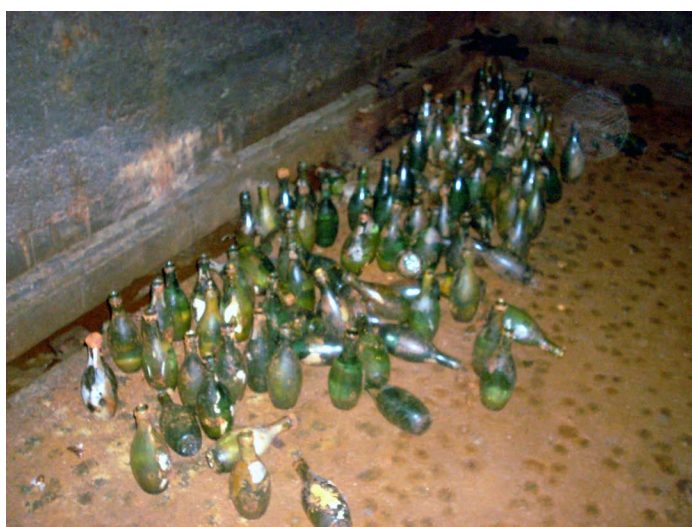
**Figure 16.** C.I.C. building: bottles of mineral water Perrier survived to the explosions, the fire and the inundation in the third underground floor.

the explosions that caused a violent fire lasting three days; the explosions also destroyed the water pumps causing the water to invade the three underground floors up to the 1.25 meters layer for a period of ten years. Important stocks of ammunitions not reached by the explosions and in perfect state of preservation and therefore in a very dangerous state were evacuated by the French Civil Protection Service (**Figure 17**). The beds date actually of the period of the war and were used by the German soldiers. The kitchen furnitures are probably of German construction (**Figure 13** and **Figure 14**). The German soldiers have well appreciated the mineral water Perrier according to the great number of bottles dating of the period of the war that survived the explosions, the fire and the inundation of the underground floors (**Figure 16**).
